Inspection Report

Mine Name: Torrey Sandstone Quarry

Permit number: M0550016

Inspection Date: May 12, 2008

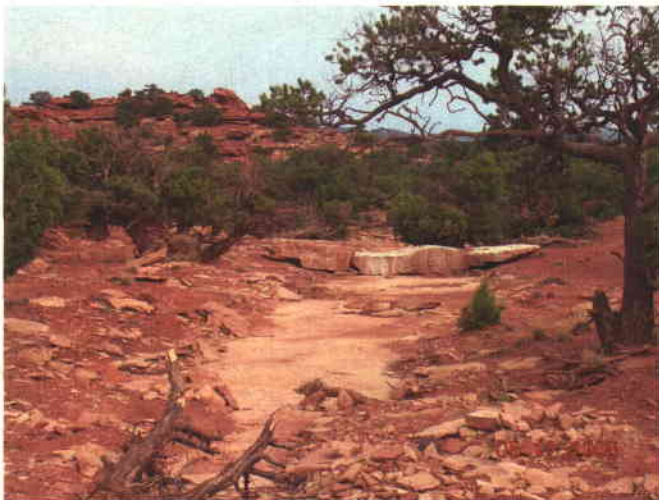
The operator committed in the reclamation plan to construct a sediment basin in the drainage at the lower end of the quarry. Photo 1 shows what has been done: Three large rocks have been placed in the drainage which would slow the water, but it would trap little if any sediment.

Photo 1. This is where the sediment trap should be and shows the three rocks that have been placed in the drainage.

The mine plan was approved April 19, 2007, and my last inspection report is dated May 11, 2007. The operator has had plenty of time to install the sediment pond committed to in the plan. Because this has not been done, I will be issuing a notice of violation requiring that this work be completed within about the next month.

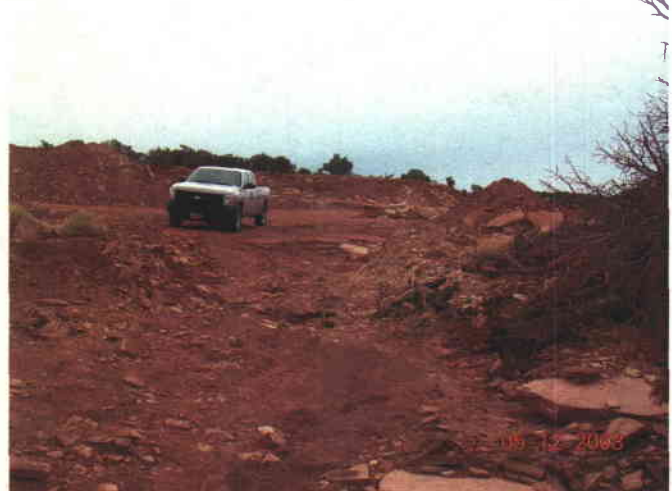
Photo 2. This shows the area upstream of the area shown in Photo 1.

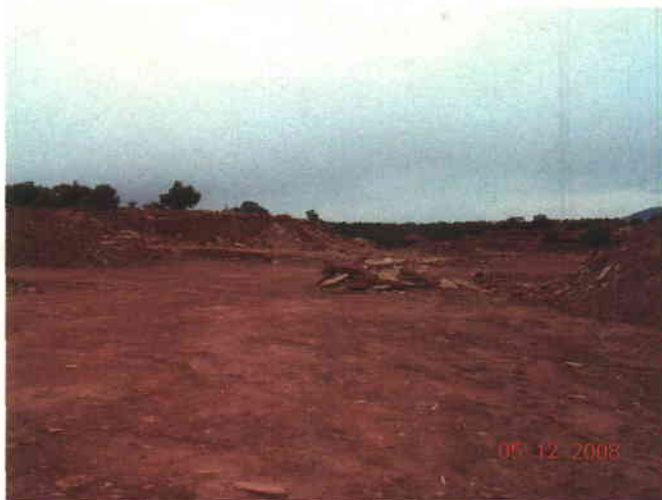
Photo 3. This picture and Photo 4 show other views of the quarry. Both were taken in the south portion of the quarry.
